**SUSTAINABLE TOURISM OBSERVATORY (STO),  
SUSTAINABLE TOURISM DEVELOPMENT  
ART DECO ARCHITECTURE  
(Snapshot assessment: Exploration, Formulation, implementative  
Architectural Art Deco As Tourism Destination Yogyakarta)**

**Muhamad and Jefrianus Immanuel Hingmo**  
Tourism Studies, Graduate School of Universitas Gadjah Mada

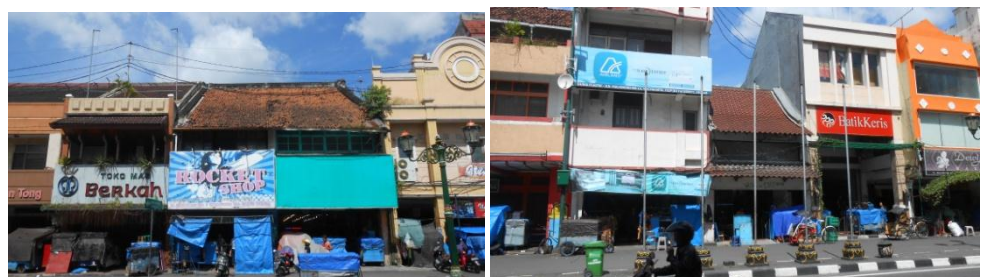
Rows of historic buildings even started switching function and undergo physical renovation that change the appearance of the building. This needs serious attention given several regions in Indonesia have experienced problems in the preservation of culture as indicated by symptoms such as changes in layout and space utilization region tend not to follow the rules of conservation, changes in building good form, function, size and ownership, changes in social and cultural life that have an impact on the appreciation and response to cultural heritage, as well as changes in neighborhoods and infrastructure that are no longer followed the original pattern or structure.

Figure Rows shopping area in the city area ( Malioboro)  
Source: Personal Documentation, 2016

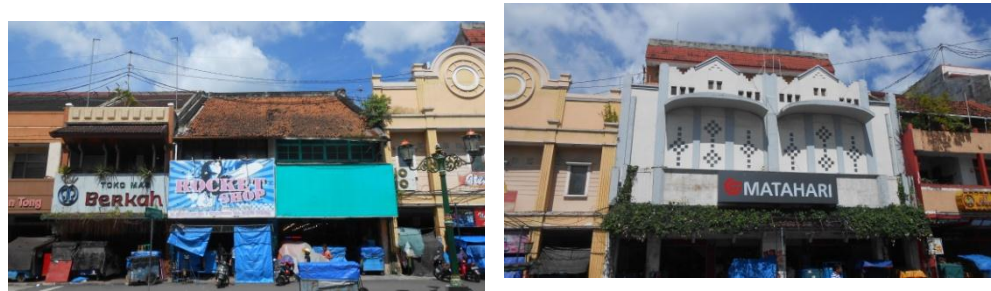
Figure A range of shopping complex at Malioboro Street  
 Source: Personal Documentation, 2015

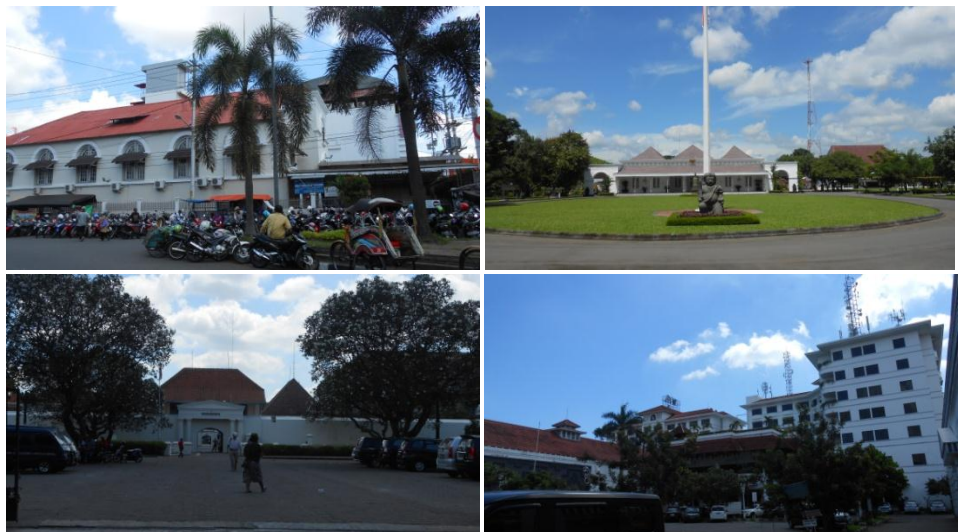
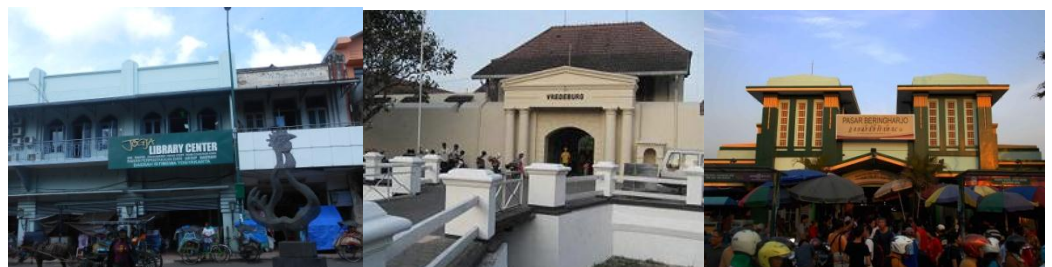
Picture: Observations buildings in the core city of Yogyakarta  
 Building is regarded as tetenger along Jalan Malioboro

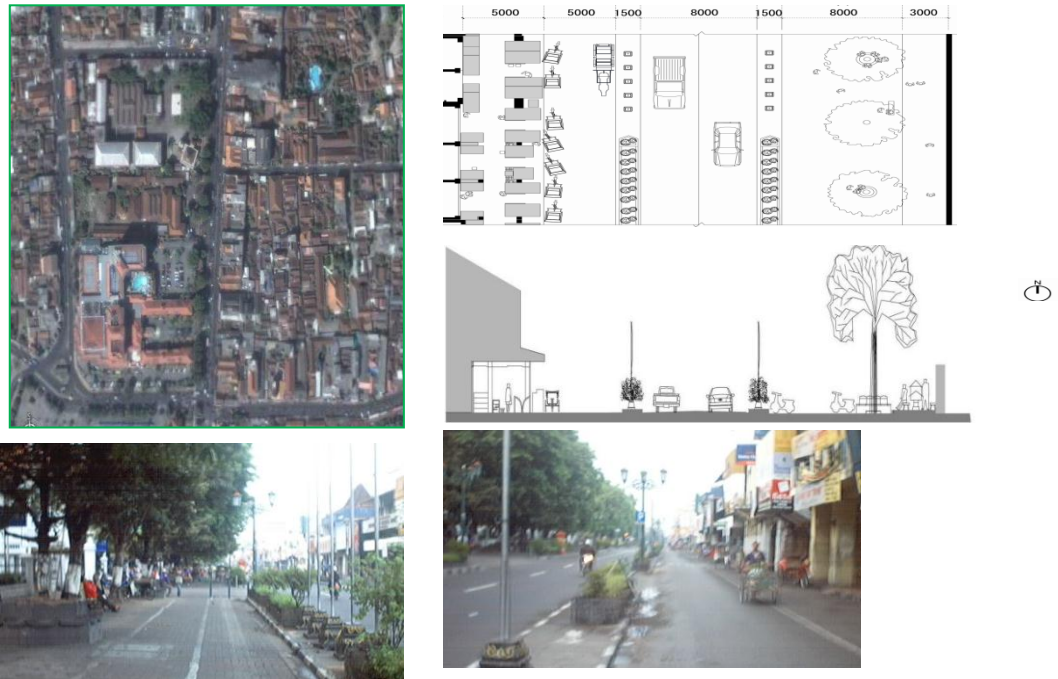
Picture . Situation Pedestrian Hand Side Quarry East (left) and the west side (right)

- In the first piece, on the west side of the area, the building still functioned as a commercial building that is retail shop. And on the east side of the neighborhood, the building serves as a commercial and governmental functions and hospitality.
- Building on the west side has a pedestrian area that is used by street vendors as a selling area, also the circulation path slower vehicles specifically for Andong and Becak.

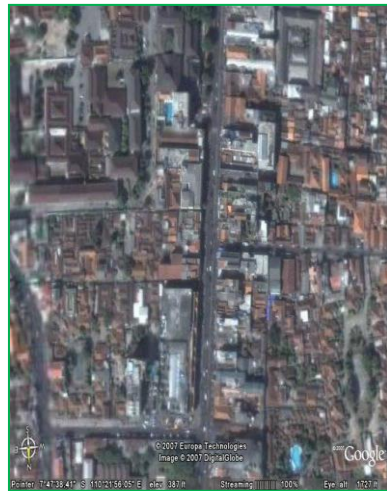
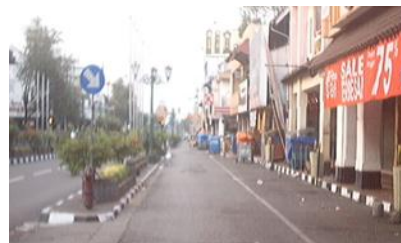
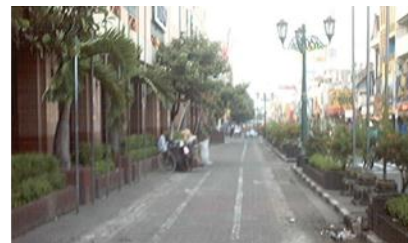
Picture observations II region Malioboro street  
(Source: Observations, 2007)

- In the second piece, the building west side of the function is the same as the first piece of the building functions on the west side or still inline with the above. And on the east side there is their public commercial functions such as building manifold Mall, and adjacent to buildings with hospitality functions, and there is still a small retail building.
- Pedestrian on the east side is used as a parking area for building Mall and surrounding areas reserved for two-wheeled vehicles (motorcycles). While on the west side, the slow lane is used exclusively for the carriage path and tricycles, which is a continuation of the circulation path cut I.

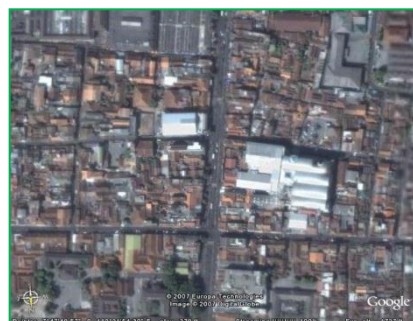
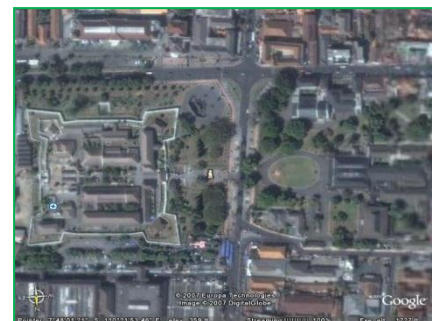
Picture observations III region Malioboro street  
(Source: Observations, 2007)

- In the third piece, there are two areas including a market area Beringharjo and area conservation areas and government buildings such as Vredeburg and the National Palace. At the regional area Beringharjo not have setfront building, so the building is used as a pedestrian area for the street vendors selling. But in the area of conservation area has setfront clear and quite spacious, free from the merchant vendors.
- Pedestrian Street is decorated with furniture in the form of bins and seating encircling the pot plant (Green Bench). Vegetation in the form of a tree with the type of Angsana still there along Beringharjo area on the east side, on the reverse side there is no vegetation. Average vegetation in the form of a banyan tree conservation area along Vredeburg and their palm trees as high as 6-8 meters along the pedestrian Istana Negara.
