Lahar at Kali Konto after the 2014 Eruption of Kelud Volcano, East Java: Impacts and Risk

Key Words: Lahar, Kelud, Geomorphic impacts, Risk

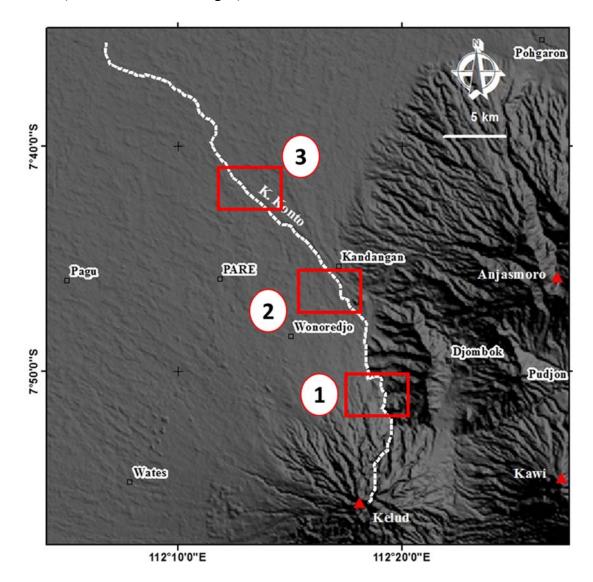
Figure 2. Location Kali Konto in northern slope of Kelud Volcano and observation site in proximal (1), medial (2), and distal (3) area (red box).

remotely-sensed findings, (b) mapping lahar deposit thickness with point measurements in proximal, medial, and distal site (Fig. 2), (d) categorizing, mapping, and classifying the level of damage house, agricultural land, and infrastructure resulting from lahar activity.

Lahar in Kali Konto occurs no more than a week after eruption phase. Nearly 25 km² area was affected due to lahar in Kali Kanto. River channel also were affected bylahar and by their morphogenic processes: riverbank erosion, channelwidening and riverbed downcutting. This processes takes an important role in generating the impact of lahar in Kali Konto. Impact of lahar that generated by lahar and geomorphic processes was observed in three locations (Fig.2) that represent three zone (proximal, medial, and distal area). This locations are Mendalan (represent proximal Fig, 2.1), Damarwulan, Kandangan (medial Fig.2.2), and Blaru, Badas (distal Fig. 2.3).

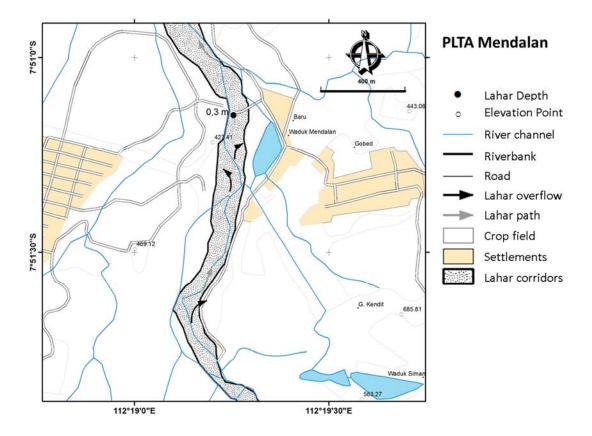
Figure 3.Formation of lahar corridors on the proximal slopeat Mendalan site

Proximal part (in Mendalan) of the Kali Konto experienced some changes as a result of lahar on 18 February 2014. Lahar was caused river widening which threatens settlement and crop field on the riverbank (Fig.3). Before the 2014 eruption, the proximal part of the Kali Konto at Mendalan was a small channel between 1.5 m and 2 m deep and 5-10 m wide. After first lahar in Kali Konto created 75-100 m wide corridors and the channel fully by lahar material.It expanded with crop field in eastward and westward of river channel. 42 houses, road network, and hydroelectricity building near the river (50-150 m) potentially damaged on the future lahar due to the pattern of river widening and lahar over flow or avulsion. The depth of the laharreached 0,3 m to 1,2 m and damaged2,3 ha crop field (Fig. 4). Crop field was buried by lahar with majority fine sand up to pebbles material.

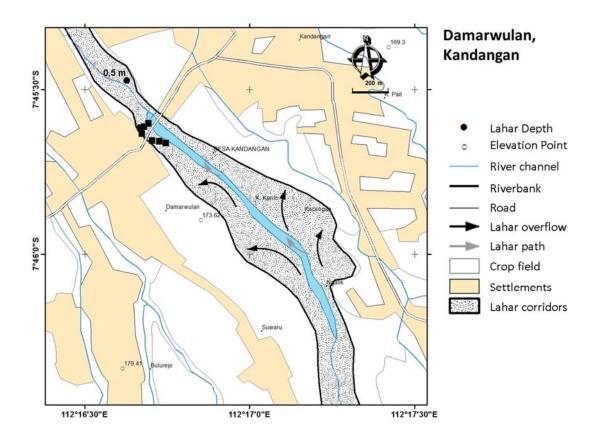
Contrary with proximal slope, the medial slope of Kali Konto in Damarwulan, Kandangan more widespread than proximal slope. Impact of lahar in Damarwulan indicated by 6 houses and 1 mosque that located in the river bank was buried by lahar (Fig.6). This houses are illegal house due to land owned by irrigation division of Public Work Department. This lahar potentially damage the settlement that located 30 m near the maximum lahar corridors. Lahar created ~60 meter wide corridors in eastward of river (before SABO DAM) and ~40 meter eastward and westward (after SABO DAM) (Fig.5). A part of the Damarwulan village was built on a 2-3 m high volcaniclastic terraceoverlooking the riverbed, and buried by 2014 lahar. The 0,5 – 1,5 meter lahar deposited in riverbank which very fine to pebble dominated (Fig. 7). The large impact in this site was caused by the morphological condition that located in the knick point.

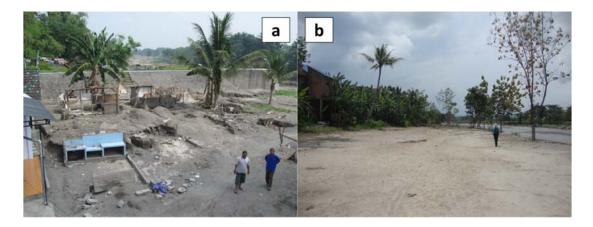
Figure 6.(a) The houses and mosque that damage due to lahar and (b) crop field
located in eastward of river channel covered by lahar

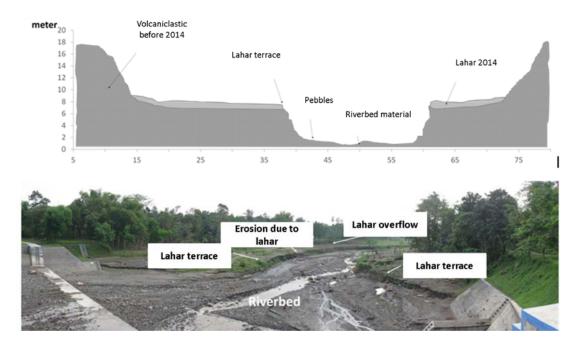
Figure 7. Cross-sectional condition on the medial slope at Kandangan site

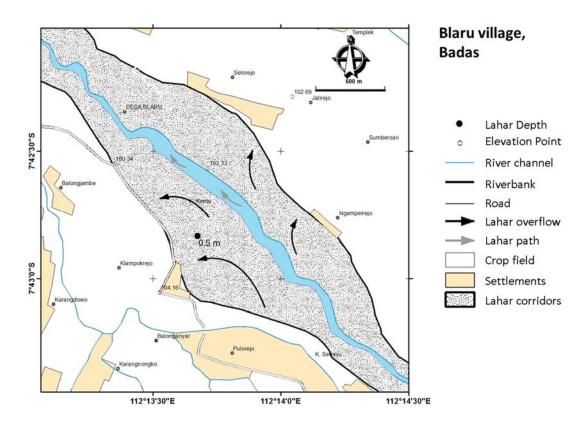
Figure 8. Formation of lahar corridors on the distal slope at Blaru site

Impact lahar in distal area showed in Blaru village that located 35 km from summit. Morphologically, this area located in gentle-flat slope. Historically, lahar more frequently has impacted in this location. It was evidenced of human made levee as far as 300 m from river side. Lahar caused river widening from 5 meter to ~ 25 meter. Lahar corridors was exceed 300 meter in both of river side and buried crop field inside levee (Fig. 8). Crop land was buried with lahar thickness 0,5 - 1 meter. Lahar deposit in Blaru different with lahar material in proximal and medial slope. Lahar overflow in the distal slope was bounded by artificial levee. The artificial levee built after lahar event 1919 to protect settlement and crop field in the vicinity. Lahar resulted aggradation in riverbed with fine-very fine sand material and it taken by mining activity (Fig. 9).

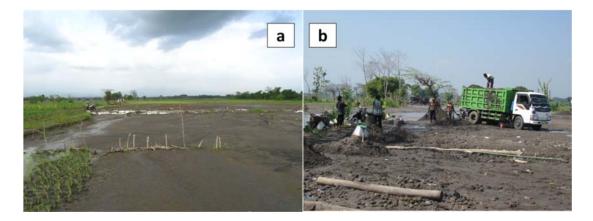
- Figure 9. (a) Crop field inside the levee that buried by lahar and (b) mining activity in Kali Konto after lahar
- 3.3. Manage a risk for future lahar in Kali Konto
